Subj: HMMT-302 AAR ser 1-69A concerning CH-46D BuNo 153343 accident
occurring 2 July 1968, pilot BAGWELL

NAVSAFECEN INVESTIGATION 1-69

SUBJECT: CH-46D Accident of Aircraft S/N 153343. Metallurgical Investigation of Failed Rotor Blade, P/N A02R1502, S/N A-2-668.

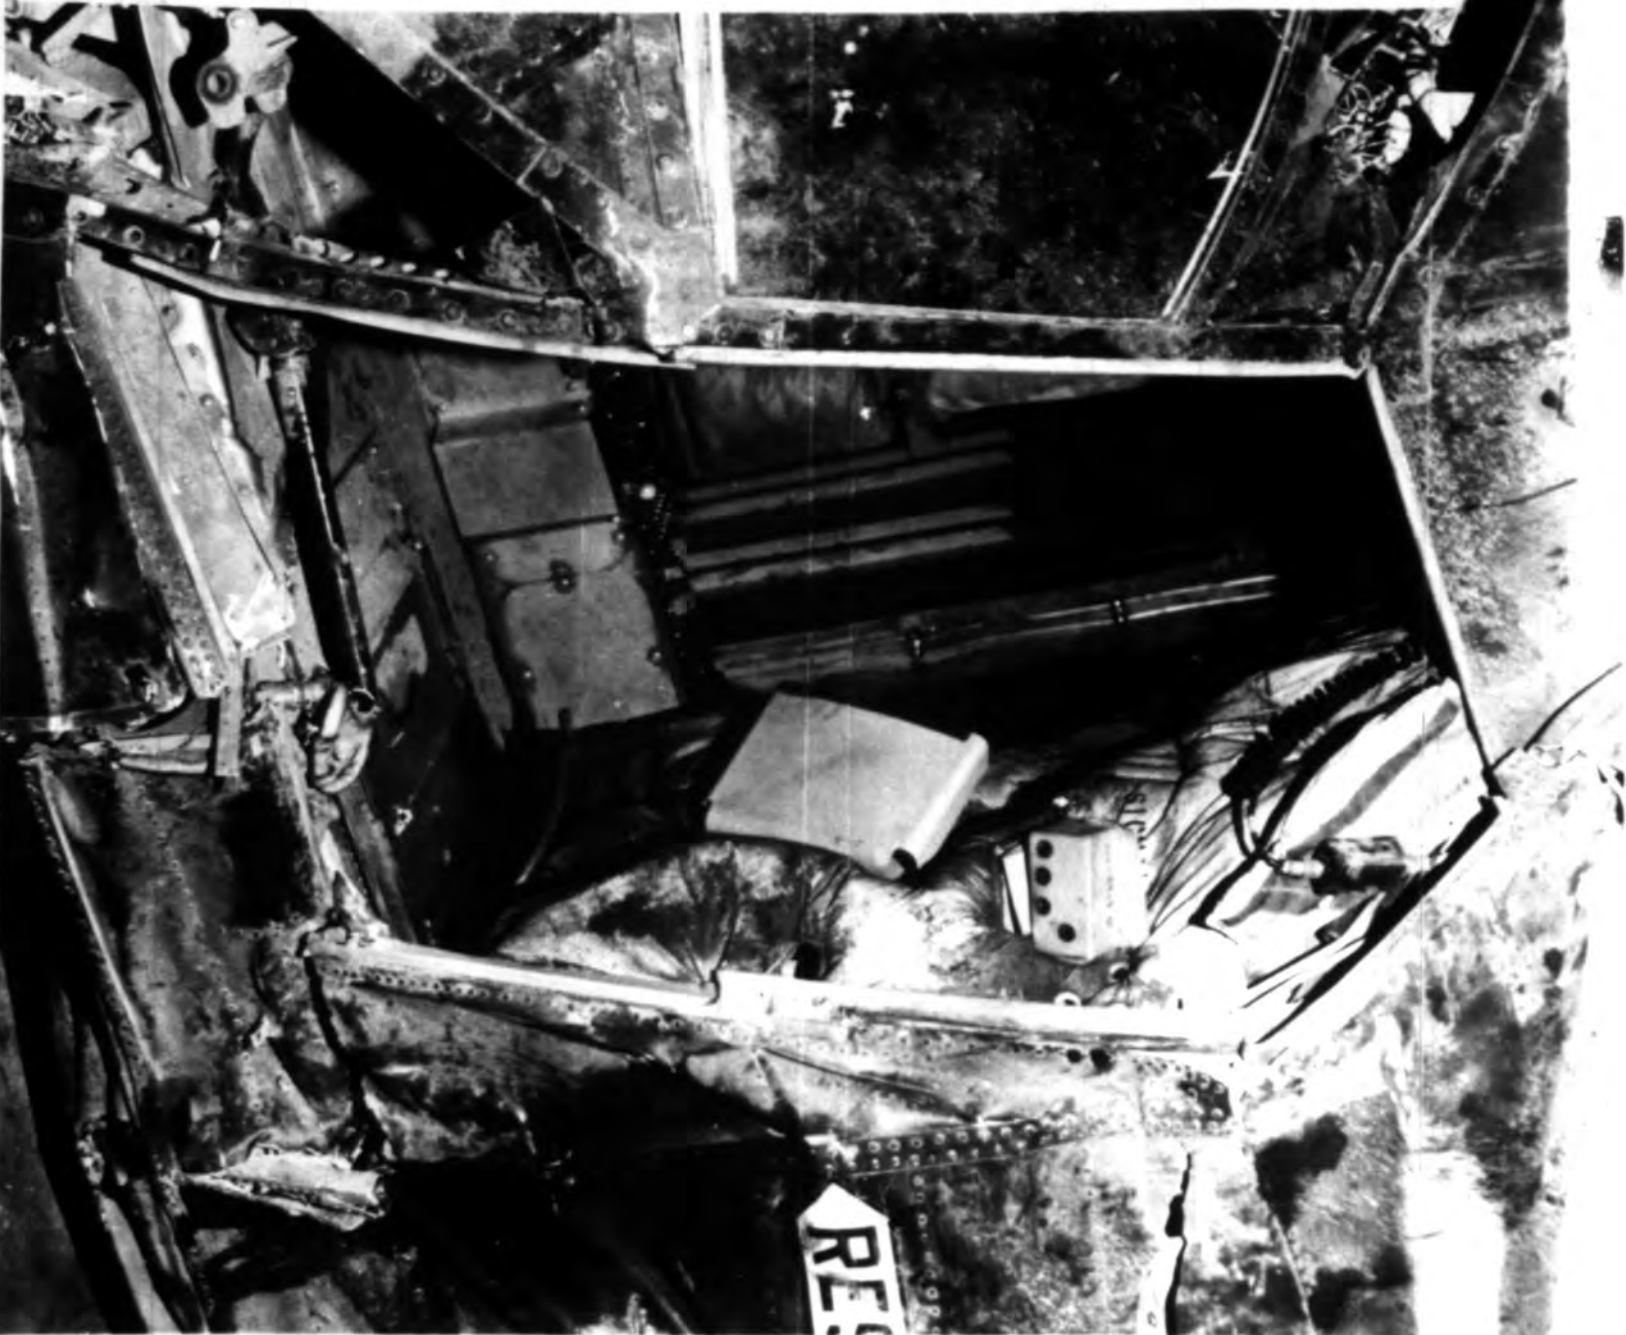
VIEW LEFT SIDE OF COCKPIT AFTER WRECKAGE WAS RIGHTED AND PILOTS SEAT REMOVED
HMMF 302, MOR 1-69 A, dtd: 2 Jul 68 PILOT BAGWELL
ENCLOSURE # 13

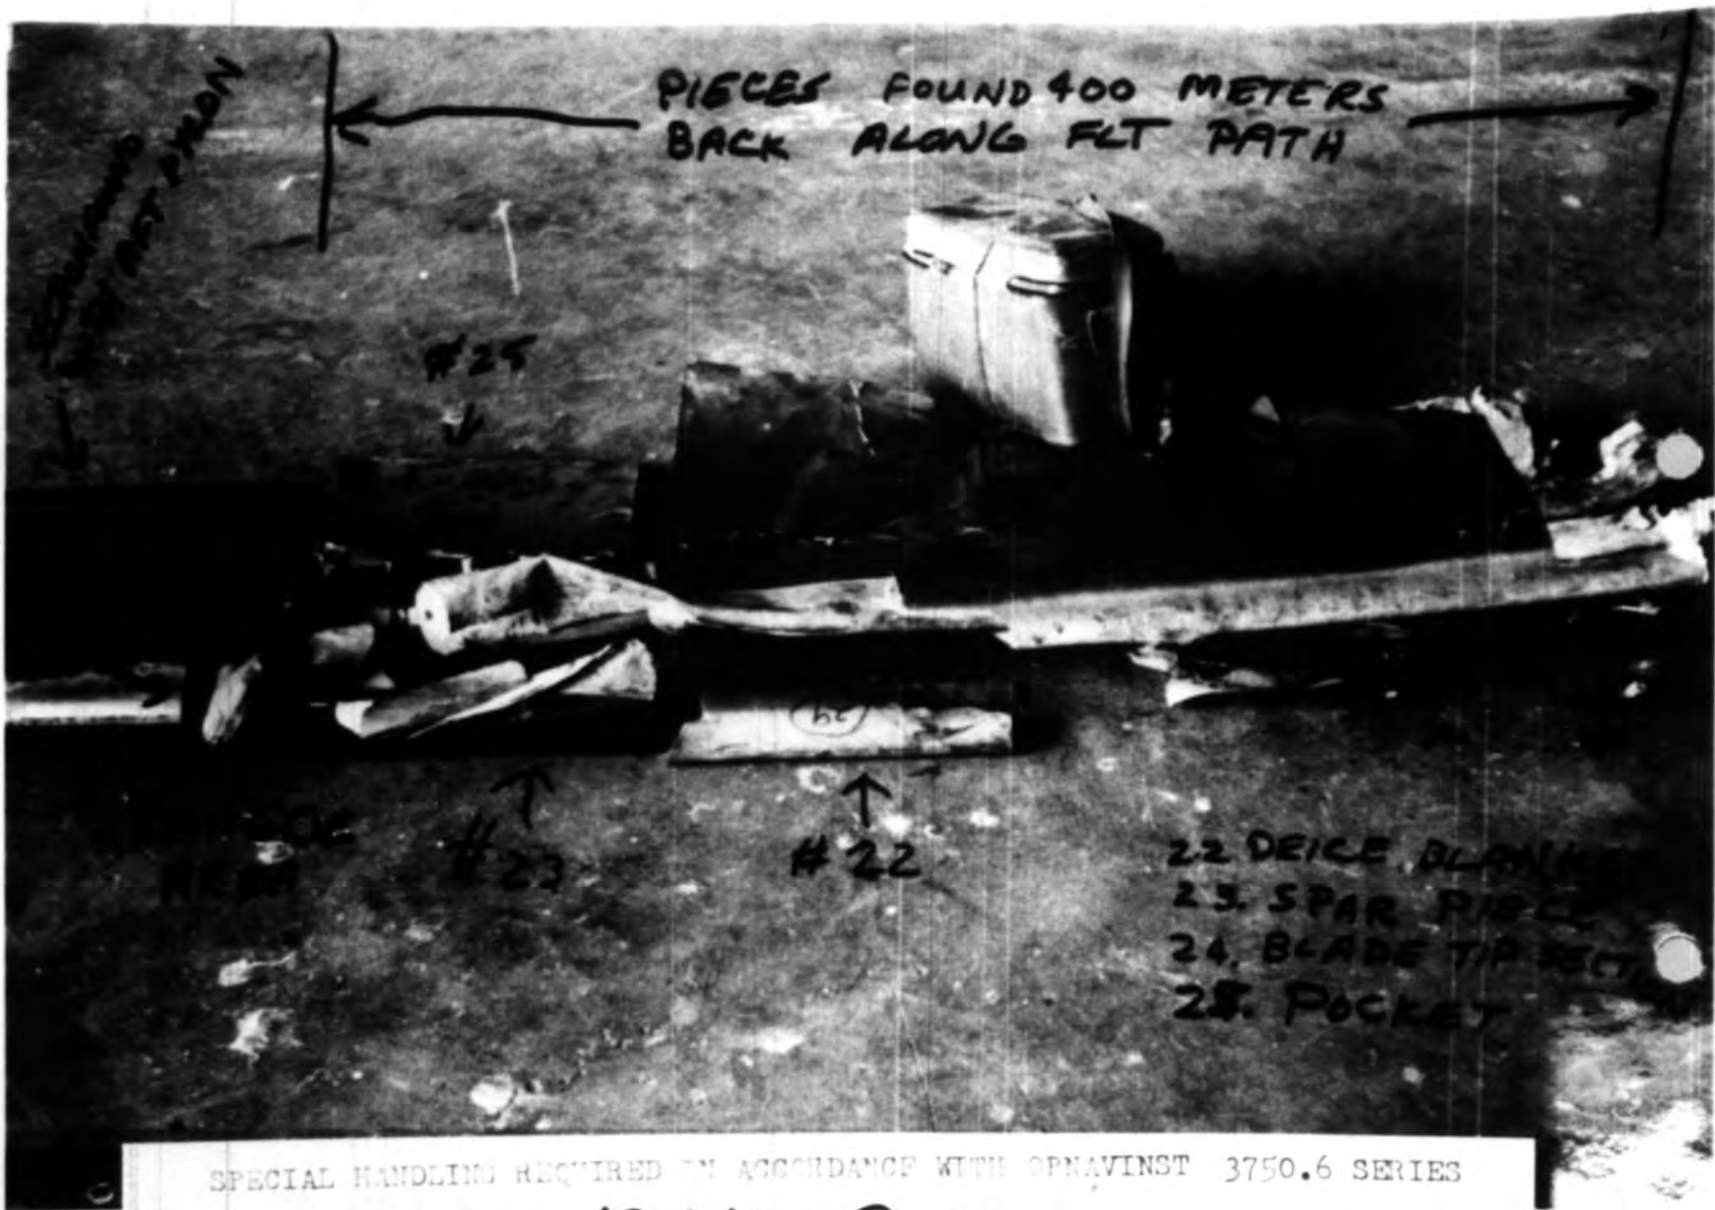
AFT YELLOW BLADE TIP SECTION

FATIGUE AREA
APT YELLOW 71
INBOARD
FATIGUE

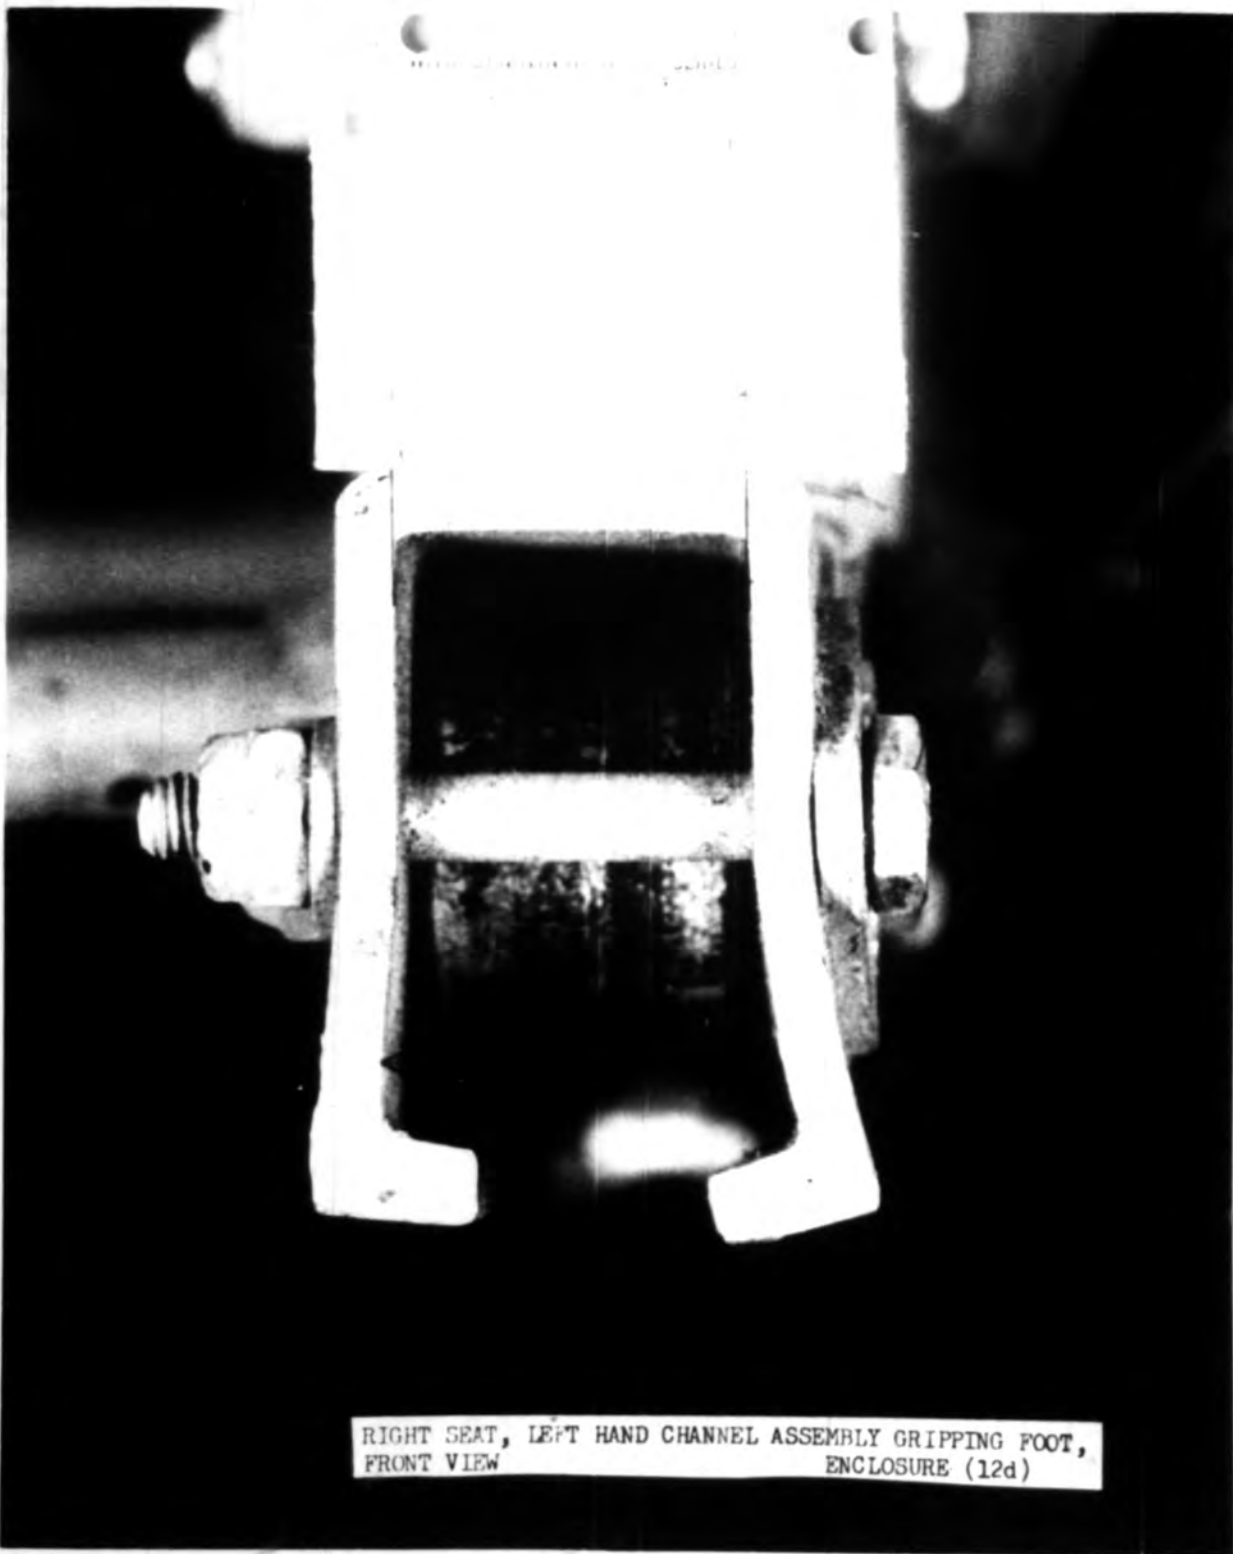
ENCLOSURE (12d)

- a. Enclosure 12a through g are submitted as an addendum to the AAR to further define the seat retention problem area.
 - b. As indicated by enclosure 12a through g, the seats separated from the I beam track installation due to failure of the channel assembly gripping feet. Both the I beam track installations and channel assembly gripping feet are constructed of an aluminum alloy.

RIGHT SEAT, LEFT HAND CHANNEL ASSEMBLY GRIPPING FOOT,
FRONT VIEW

f. It is highly recommended that the present aluminum channel assemblies be replaced by channel assemblies having greater G load factors than the flooring where they are attached. If there is to be a failure in this area, the tearing of the retained flooring will assist in decelerating the impact forces and this is far more acceptable than that of channel assembly and track installation separation. The possibility of utilizing steel channel assemblies and track installations should be studied.

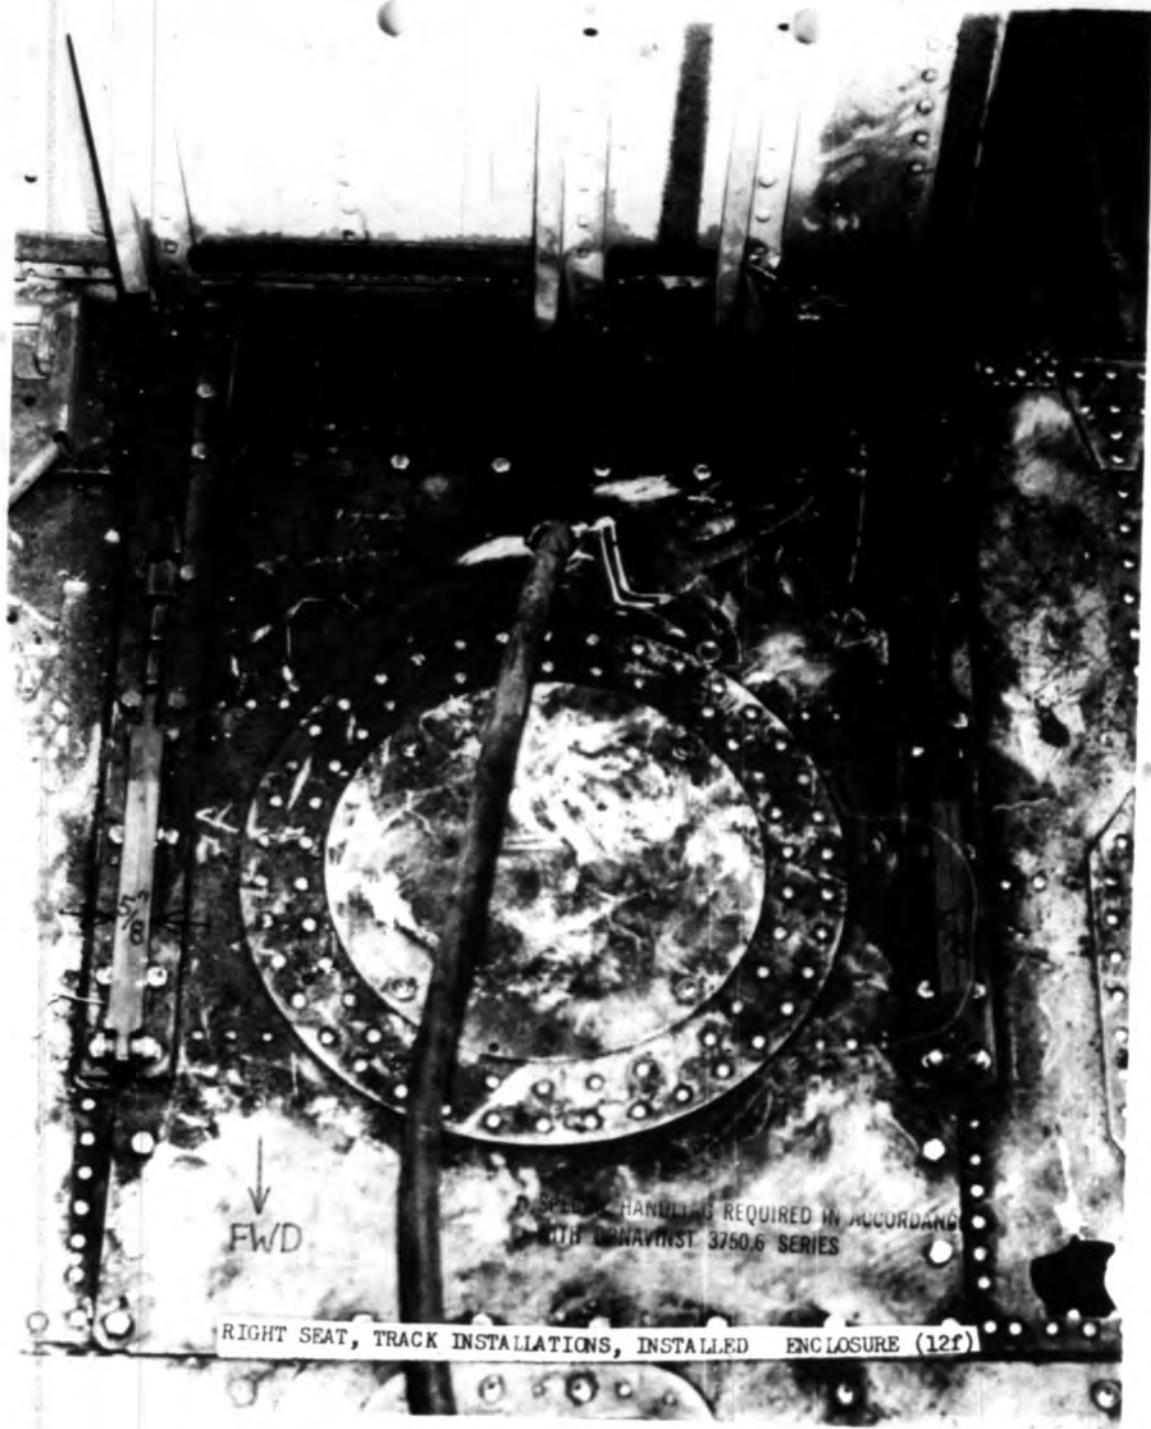
c. As shown in enclosure 12e, f and g, the I beam track installations and adjacent floor area were undamaged in this accident. The I beam track installations are made with narrow portions in the center section to facilitate removal and this is not to be construed as a damaged area in the enclosures.

RIGHT SEAT, TRACK INSTALLATIONS ENCLOSURE (12e)
